# JOINT TRANSPORTATION RESEARCH PROGRAM

## Assessment of Bridges Subjected to Vehicular Collision

Wang, Y., & Thrall, A. P. (2019). *Assessment of bridges subjected to vehicular collision* (Joint Transportation Research Program Publication No. FHWA/IN/JTRP-2019/01). West Lafayette, IN: Purdue University. <https://doi.org/10.5703/1288284316870>

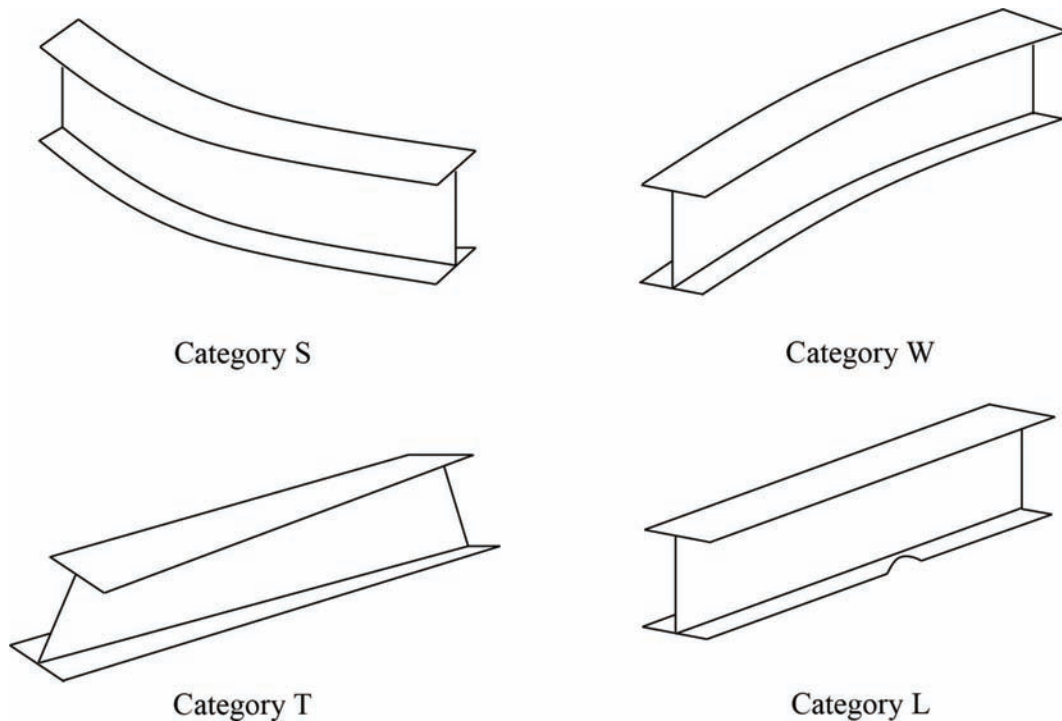
**Figure 1.3** Categories of damage (adapted from FHWA, 2015).

as: (1) strong or major axis bending (Category S), (2) weak or minor axis bending (Category W), (3) torsion about the longitudinal axis (Category T), and (4) local damage including flange bulges and web buckles (Category L) (Figure 1.3). Events typically cause damage that is as a combination of these categories (FHWA, 2015). Category T and L damage is most frequently observed for composite bridges, while Category W and L is more likely for non-composite bridges (Varma & Kowalkowski, 2004). After damage, an engineer must determine if repair is necessary, and if so, what type of repair should be performed (FHWA, 2015). There are currently no available guidelines for bridge inspectors to assess damage and to make repair decisions.

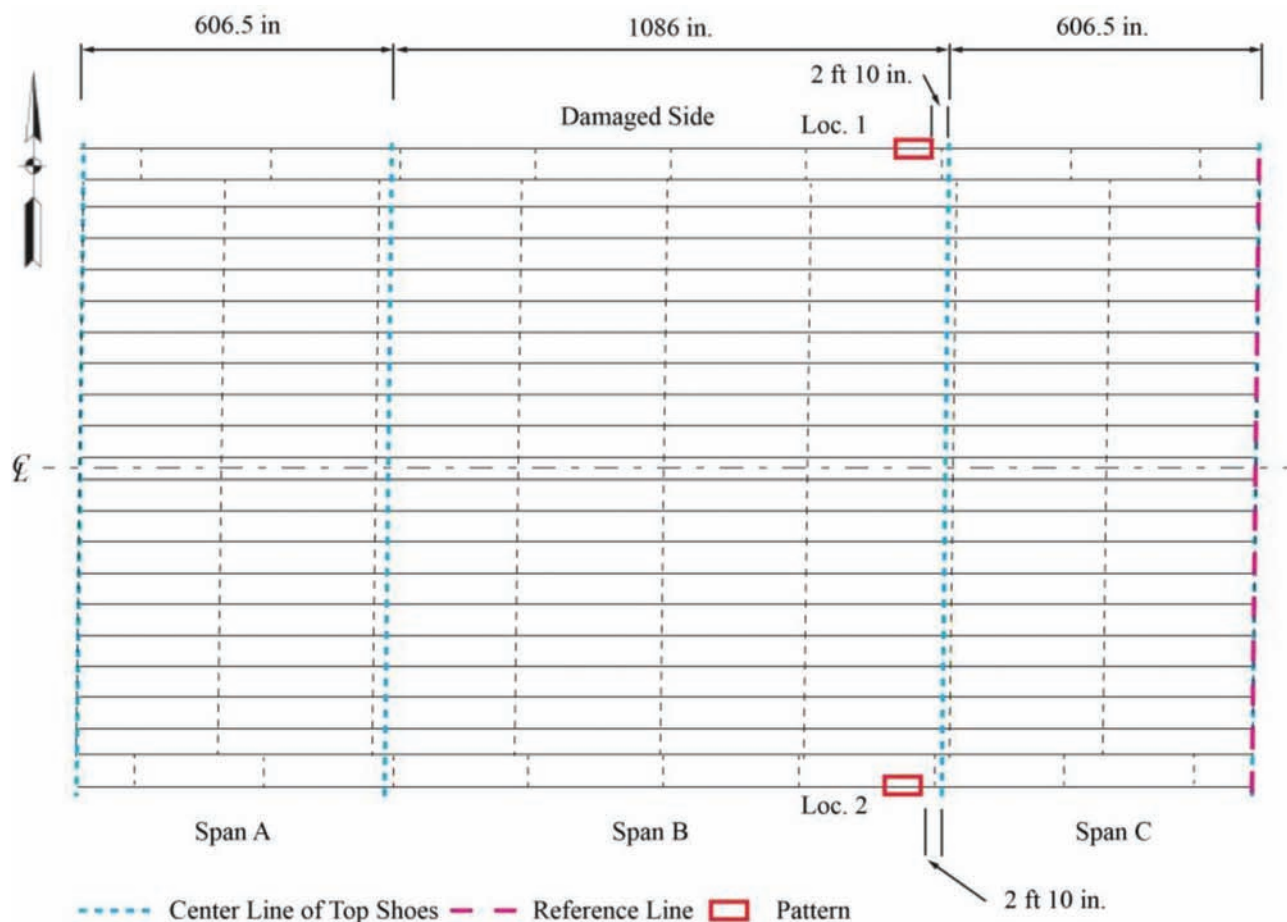
Figure 4.3 Framing plan and pattern locations for Asset 020-71-04052.

Asset 020-71-04052 (Figure 4.2 and Figure 4.3) is a three-span (50 ft. 6 in., 90 ft. 6 in., 50 ft. 6 in. spans) continuous composite bridge in South Bend, IN, built in 1966 and reconstructed in 1997. In 2016, 14 of the 22 girders were damaged near the East pier by a collision from an equipment hauler, with the heaviest damage incurred by the North exterior girder (Figure 4.4). Because of the vehicular collision, the lower flange was plastically deformed with a sweep of approximately 16 in. The bearing was also kicked out and retrofitted with a wedge.

Two girders were monitored (Figure 4.3): (1) severely damaged exterior girder (Location 1) and (2) less damaged symmetric exterior girder (Location 2). Location 1 is the location of the worst damage. Location 2 was selected as a symmetric location on a less damaged girder for comparison. Ideally, a symmetric undamaged girder would have been monitored. However, this was not possible, as some collision damage had occurred at Location 2. The behavior of the webs and bottom flanges were monitored. At Location 1, the bottom of the bottom flange and the North face of the web were monitored. At Location 2, the top of the bottom flange and the South face of the web were monitored.

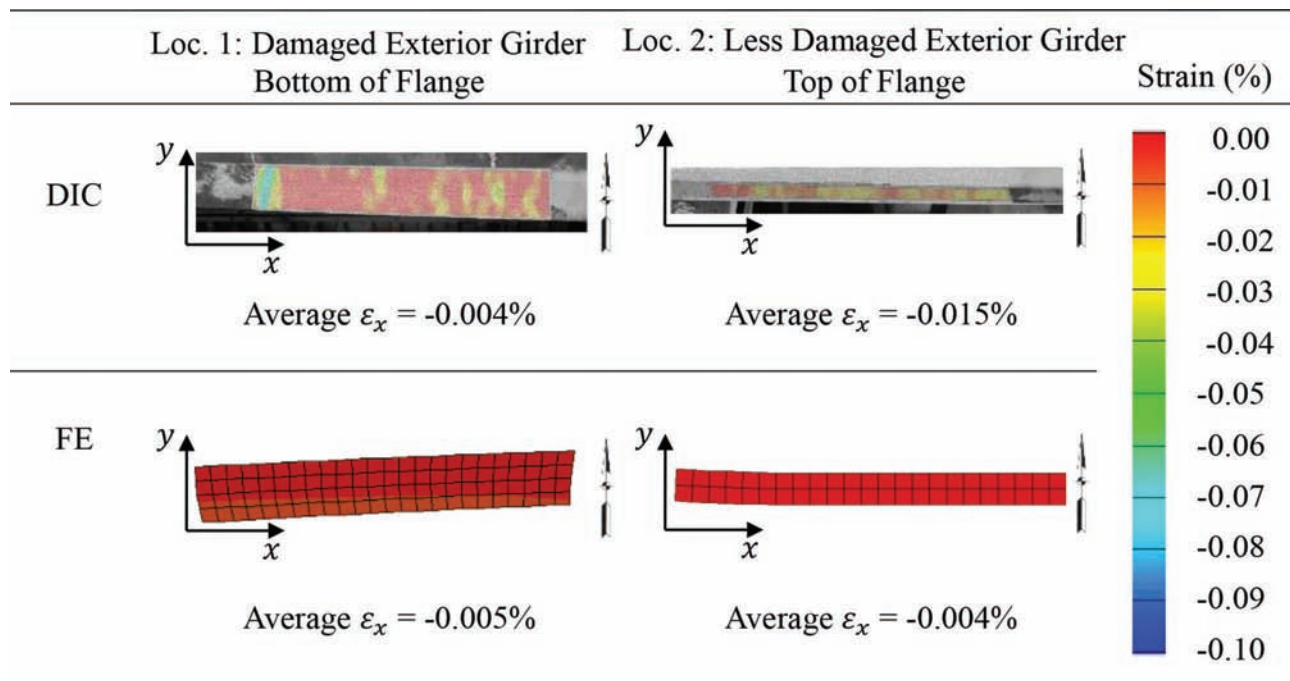
**Figure 4.6** Measured and FE predictions (tied model) of strains in the bottom flanges of Asset 020-71-04052 under peak negative moment.

Figure 4.6 and Table 4.3 show that strain in both girders is very small, demonstrating conservatism in design. The measured strain in the damaged girder (Location 1) is much smaller than the less damaged symmetric girder (Location 2). This suggests that load is being redistributed away from the damaged girders. Railing participation is likely an important considera-

tion in this redistribution, as well as participation of adjacent girders. The FE prediction for the damaged girder using the tied model matches the measured data very well (full-field maps shown in Figure 4.6). The untied scenario results in smaller strains in the damaged girder. For the undamaged side, the FE prediction is less than the measurement. This is because the exterior girder on the undamaged side is also damaged and deformed inward. Figure 4.7 shows the FE strain distribution in the monitored region. Compared to the inner side, the monitored region has a lower average strain. This is because the strain distribution is very sensitive to the geometry of the damage. If more information is available on the less damaged side, better agreement could potentially be achieved between FE prediction and measured DIC results.

Pattern location	DIC	FE
Loc. 1: Damaged Exterior Girder	-0.004%	-0.005% (tied) -0.002% (untied)
Loc. 2: Less Damaged Exterior Girder	-0.015%	-0.004%

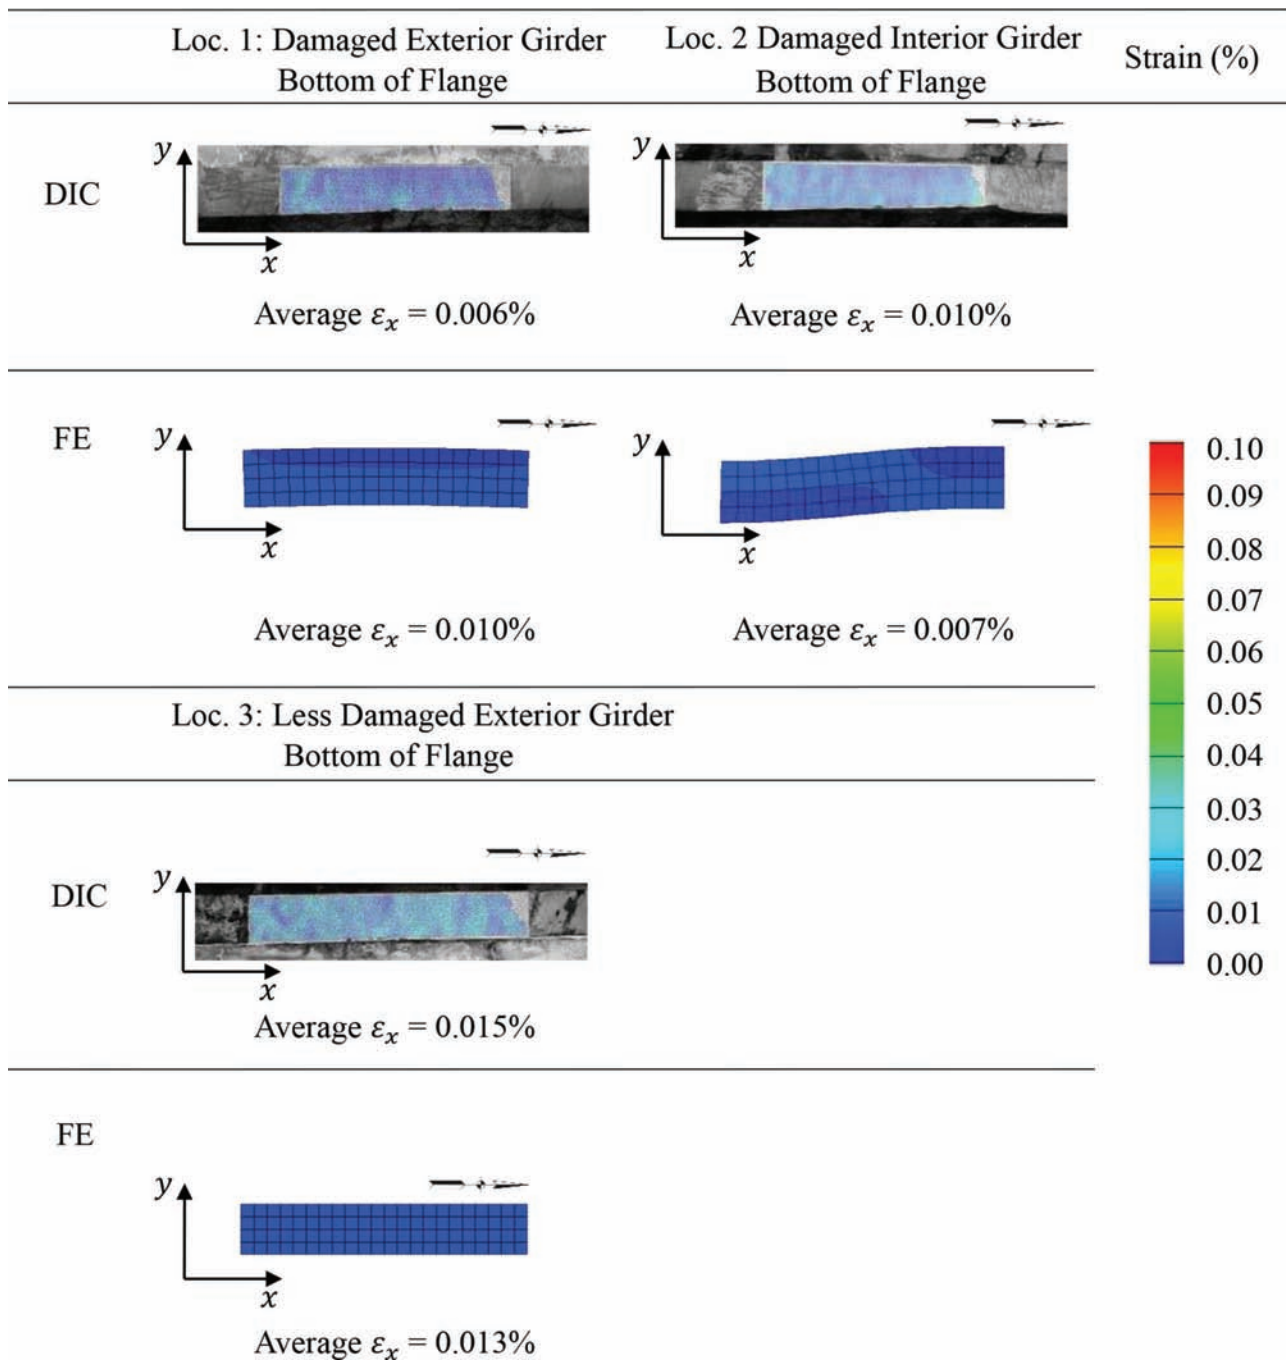
Figure 4.13 and Table 4.5 show the measured DIC strains and FE predictions under peak positive moment. Overall, the strains are very small, again demonstrating conservatism in design. Since the measured strains are so small, the later studies focused on locations corresponding to where peak moment can be induced, as opposed to the location of the worst damage.

**Figure 4.13** Measured and FE predictions (tied with curb) of strains in the bottom flanges in Asset 030-02-04803 under peak positive moment.

Location	DIC	FE with curb	FE without curb
Loc. 1: Damaged Exterior Girder	0.006%	0.010% (tied) 0.011% (untied)	0.014% (tied) 0.018% (untied)
Loc. 2: Damaged Interior Girder	0.010%	0.007% (tied) 0.009% (untied)	0.009% (tied) 0.011% (untied)
Loc. 3: Undamaged Exterior Girder	0.015%	0.013% (tied) 0.018% (untied)	0.020% (tied) 0.026% (untied)
Undamaged Interior Girder	N/A	0.009% (tied) 0.010% (untied)	0.012% (tied) 0.014% (untied)

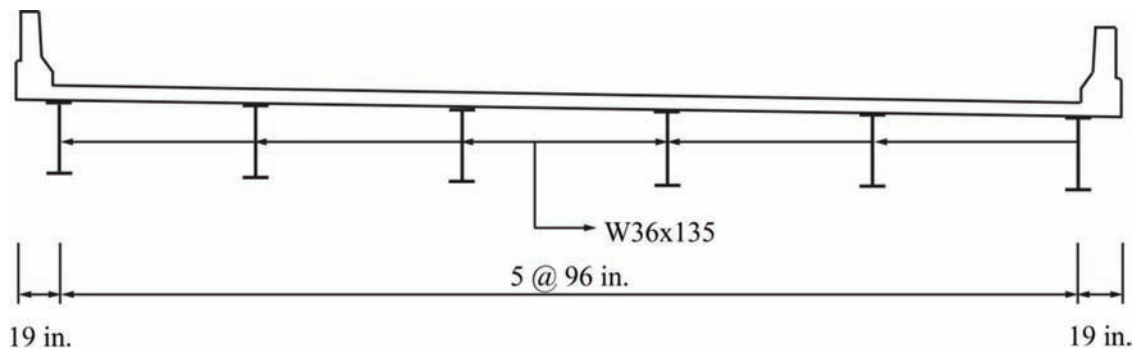
Figure 4.14 Cross-section of Asset 037-55-05265.

Asset 037-55-05265 (Figure 4.14 and Figure 4.15) is a two-span (70 ft. each) continuous composite bridge in Martinsville, IN, built in 1966 and reconstructed in 1990. All beams over SR 39 Northbound have some collision damage. The bridge has been hit several times; one collision was reported in 2013 and another one in

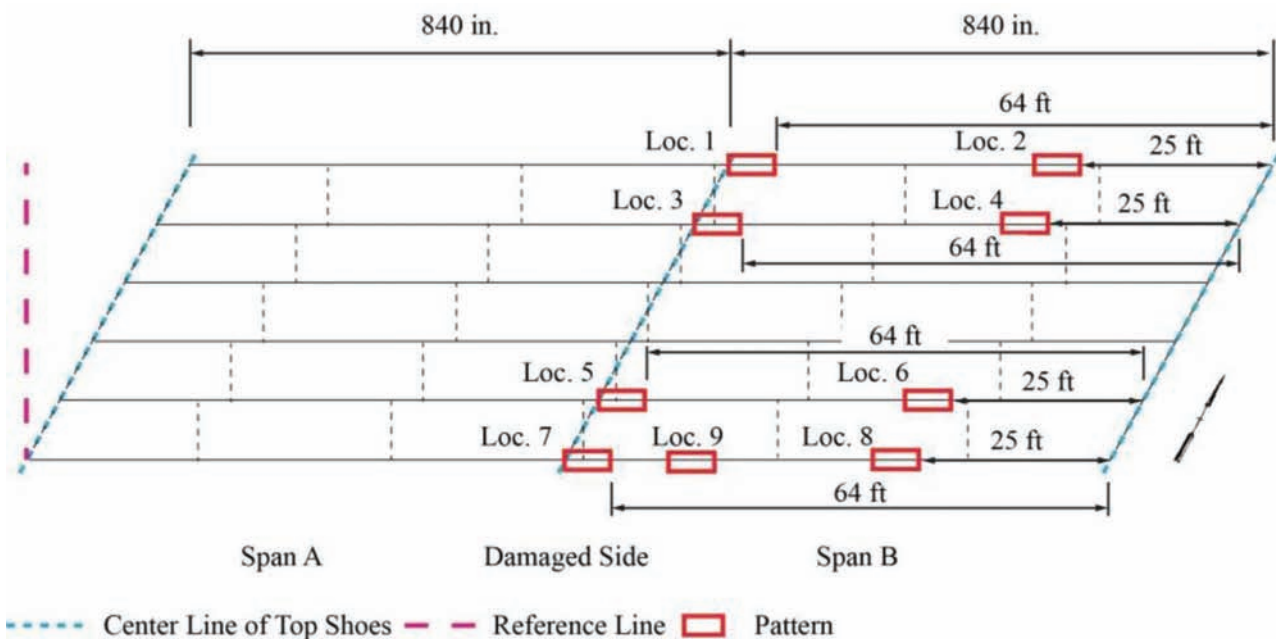
Figure 4.15 Framing plan and pattern locations for Asset 037-55-05265.

Four girders were monitored (Figure 4.15): (1) an undamaged exterior girder (Locations 1 and 2), (2) an undamaged interior girder adjacent to the undamaged exterior girder (Locations 3 and 4), (3) an undamaged interior girder adjacent to the damaged exterior girder (Locations 5 and 6), and (4) a damaged exterior girder (Locations 7, 8, and 9). Locations 1, 3, 5, and 7 were monitored as peak negative moment can be induced at these locations. Locations 2, 4, 6, and 8 were monitored as peak positive moment can be induced at these locations. Location 9 corresponds to the worst damage. The bottom of the bottom flanges were monitored.

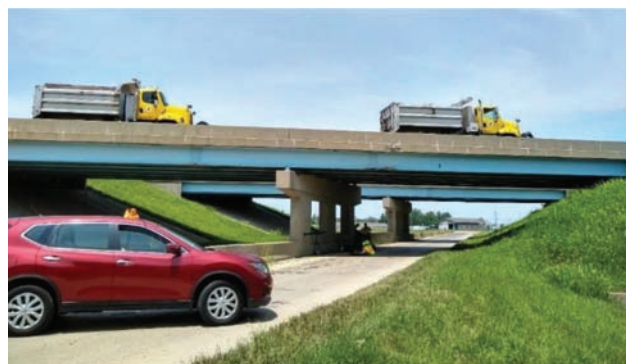
Figure 4.17 Load testing for Asset 037-55-05265.

Field work by the researchers was carried out over 2 days, facilitated by Seymour District Maintenance Crews, Seymour District Bridge Inspectors, and INDOT Research & Development Staff (Figure 4.17). Load testing was performed to induce peak negative moment and peak positive moment, with truck locations indicated in Table 4.6 (trucks were positioned 1 ft.

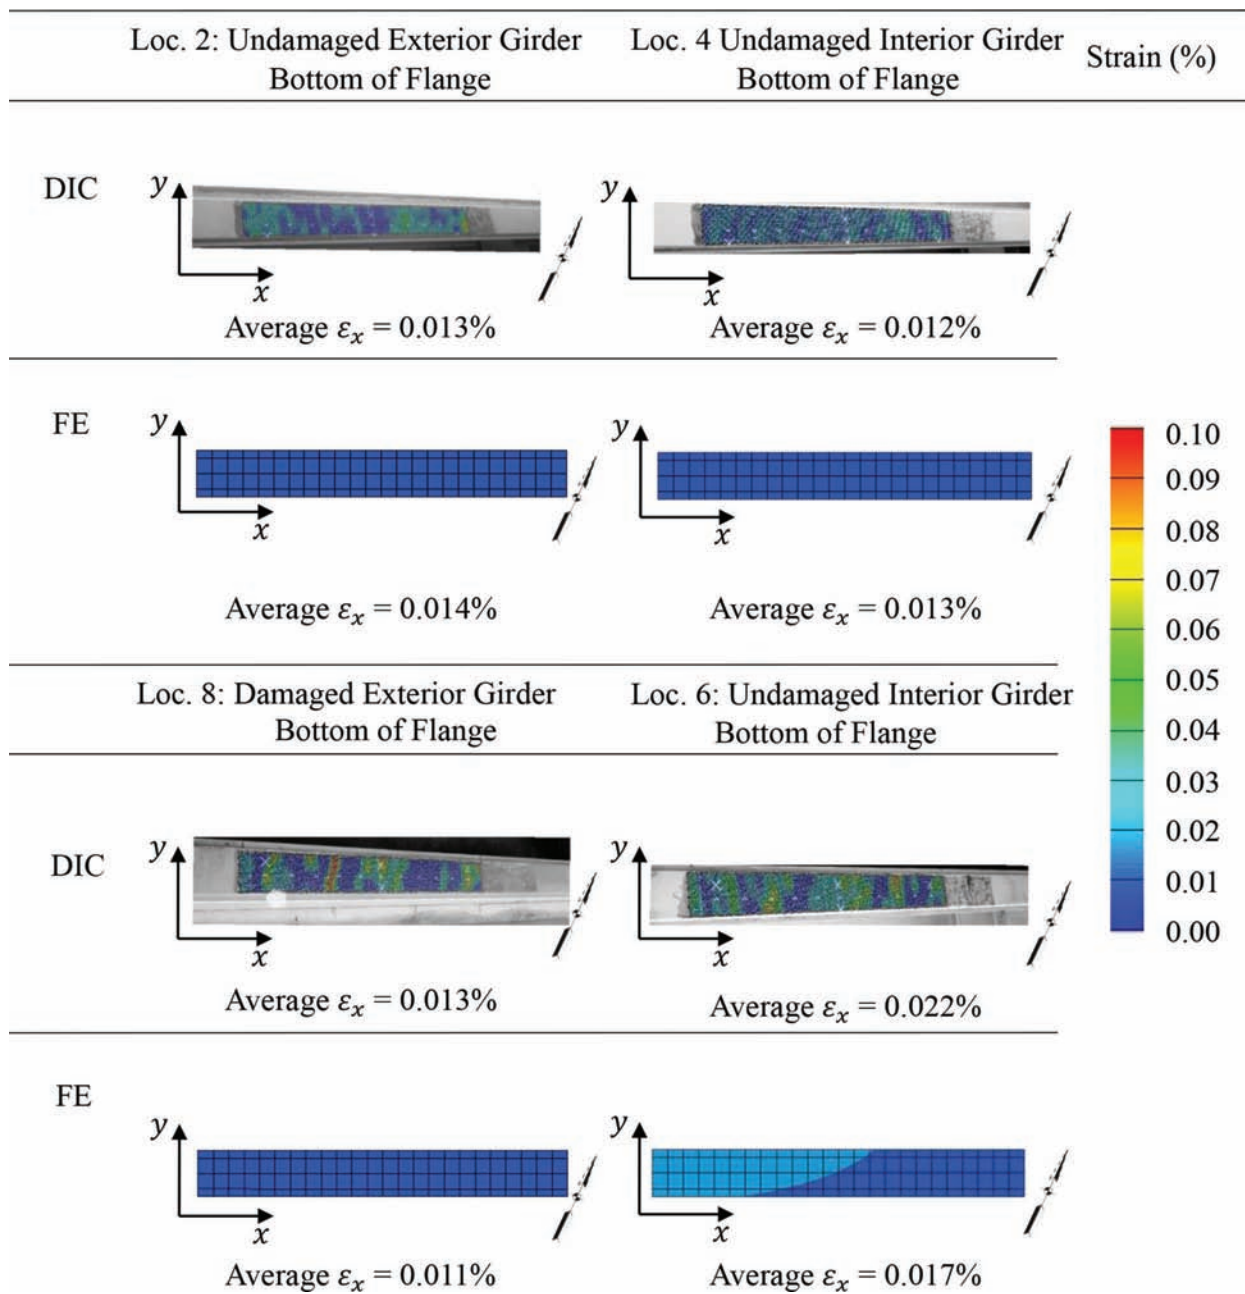
Figure 4.18 and Table 4.7 show the measured and predicted strains under peak positive moment. Again, the measured strains are small, indicating conservatism. The measured strains in the exterior girders (i.e., Locations 2 and 8) are comparable. However, the interior girder adjacent to the damaged girder (i.e., Location 6) carries more strain than any of the other girders. This demonstrates that the damaged girder is shedding its load to the adjacent girder. On the damaged side, different interactions between the concrete deck and the damaged girder were investigated numerically: (1) the damaged girder and the deck are acting compositely (tied); (2) the damaged girder and the deck are acting as non-composite between the 3rd and 5th diaphragm from the West and the coefficient of friction is 0.65 (untied 1); (3) the damaged girder and the deck are acting as non-composite in the damaged span and the coefficient of friction is 0 (untied 2); (4) the damaged girder and

the deck are acting as non-composite in the damaged span and the coefficient of friction is 0.65 (untied 3). By removing the composite behavior over the entire damaged span and assuming no friction between the top flange and the deck (i.e., untied 2), the FE predictions most closely match the DIC measurements and are featured in Figure 4.18. This demonstrates that the shear connection between the girder and the deck may be damaged due to vehicular collision.

**Figure 4.18** Measured and FE predictions (with damaged girder untied over the entire damaged span) of strains in the bottom flanges in Asset 037-55-05265 under peak positive moment.

Location	DIC	FE
Loc. 2: Undamaged Exterior Girder	0.013%	0.014%
Loc. 4: Undamaged Interior Girder	0.012%	0.013%
Loc. 6: Undamaged Interior Girder	0.022%	0.013% (tied)
		0.014% (untied 1)
		0.017% (untied 2)
		0.016% (untied 3)
Loc. 8: Damaged Exterior Girder	0.013%	0.015% (tied)
		0.014% (untied 1)
		0.011% (untied 2)
		0.012% (untied 3)

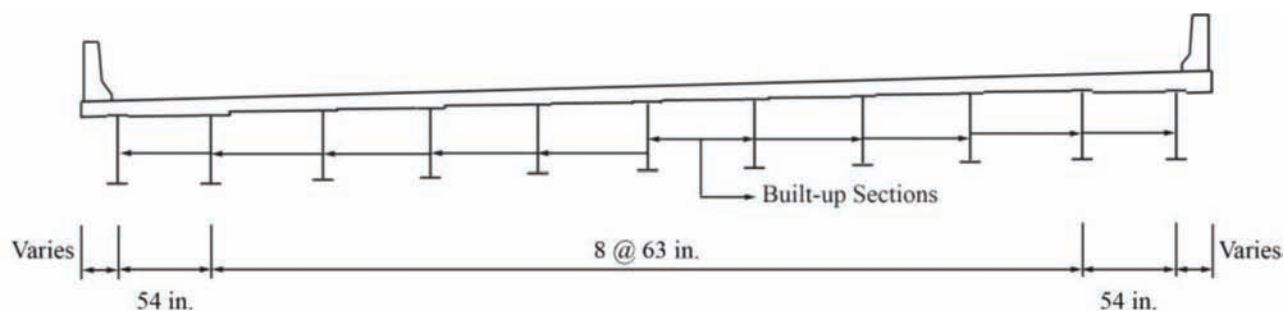
**Figure 4.19** Cross-section of Asset (45)46-53-05993.

Asset (45)46-53-05993 (Figure 4.19 and Figure 4.20) is two-span (96 ft. each) continuous non-composite bridge in Bloomington, IN, built in 1971 and reconstructed in 2003.

On August 21, 2018, a lift struck the East exterior girder in the North span. The girder was bent inward approximately 13 in. and the diaphragms punched through the girder in four locations including a hole near the splice plate at the approximate location of the impact (Figure 4.21). The Business Owner called the Principal Investigator that day to mobilize monitoring of this structure prior to any repairs. The researchers rapidly responded and performed monitoring—facilitated by

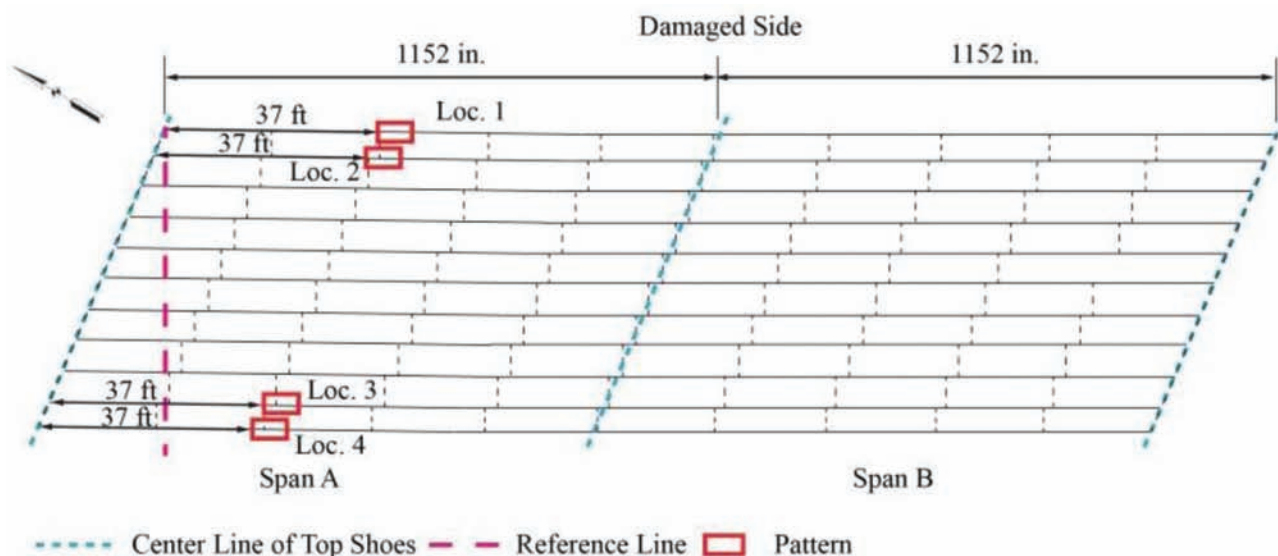
**Figure 4.20** Framing plan and pattern locations for Asset (45)46-53-05993.

Four girders were monitored (Figure 4.20): (1) a damaged exterior girder (Location 1), (2) an undamaged interior girder adjacent to the damaged girder (Location 2), (3) an undamaged interior girder (Location 3), and (4) an undamaged exterior girder (Location 4). Monitored regions were selected as peak positive moment

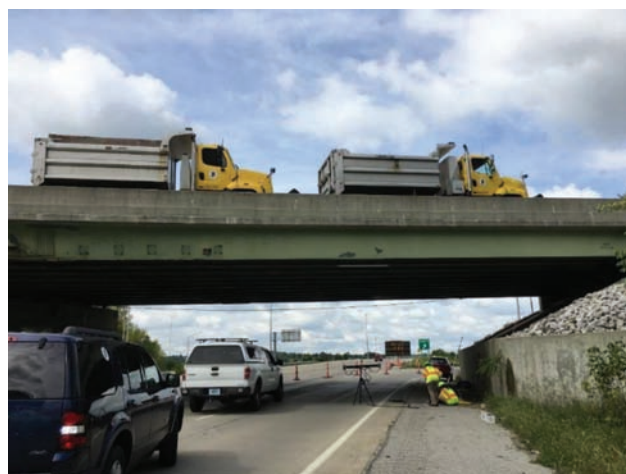
**Figure 4.22** Load testing for Asset (45)46-53-05993.

Seymour District Maintenance Crews and Bridge Inspectors—on September 12, 2018, with both pattern application and monitoring occurring in the same day (Figure 4.22). While all other studies waited 48 hours between pattern application and monitoring to ensure cure time for the tape adhesive, this work was all performed in a single day. Tensile testing demonstrated that the adhesive provided sufficient bond immediately and therefore that monitoring could be performed immediately.

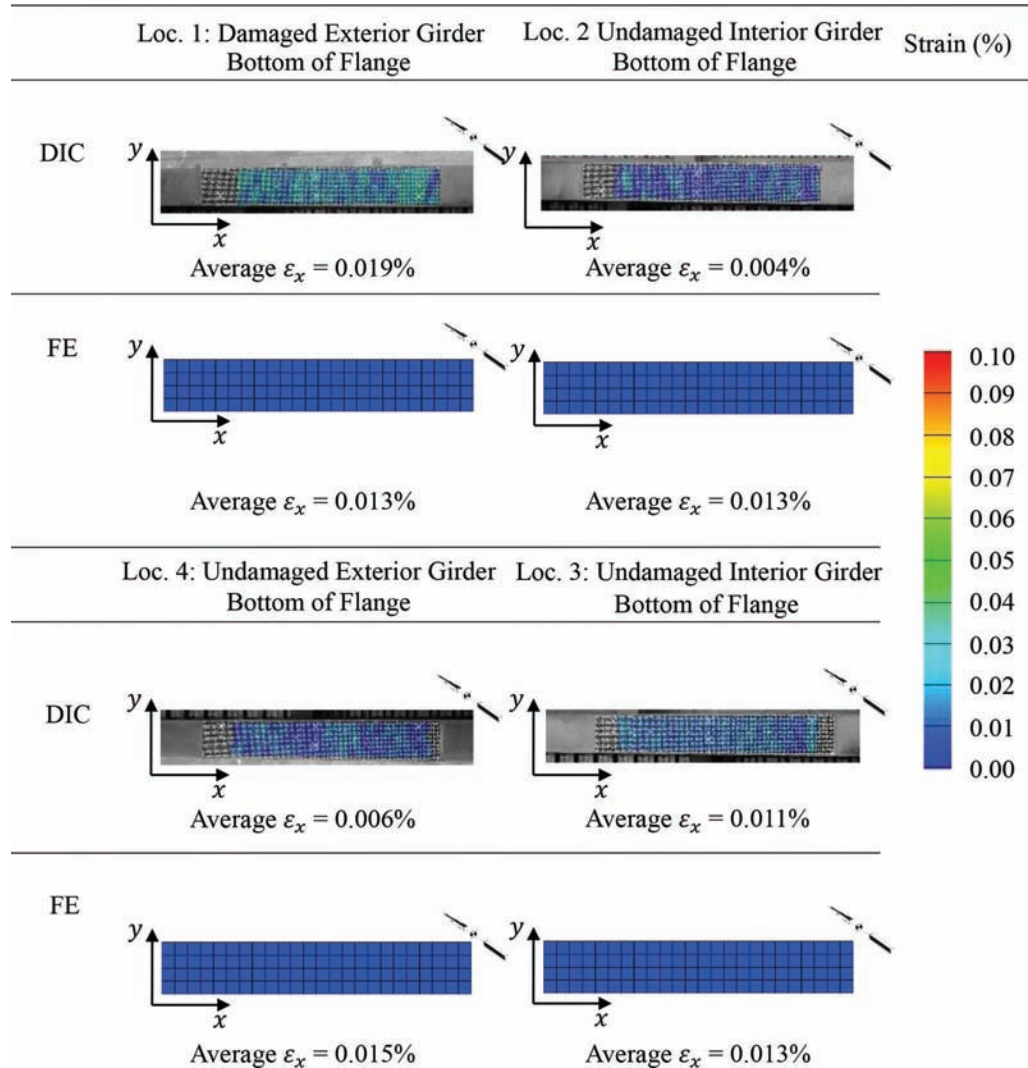
Figure 4.23 and Table 4.9 shows the measured and predicted strains under peak positive moment. Again, the strains are small, indicating conservatism. A notable

Figure 4.23 Measured and FE predictions (tied with cracks) of strains in the bottom flanges in Asset (45)46-53-05993 under peak positive moment.

Location	DIC	FE
Loc. 1: Damaged Exterior Girder	0.019%	0.0129% (tied with 4th diaphragm) 0.013% (tied without 4th diaphragm) 0.005% (untied without 4th diaphragm) 0.013% (with hole) 0.0132% (with cracks)
Loc. 2: Undamaged Interior Girder	0.004%	0.0130% (tied with 4th diaphragm) 0.013% (tied without 4th diaphragm) 0.018% (untied without 4th diaphragm) 0.013% (with hole) 0.0133% (with cracks)
Loc. 3: Undamaged Interior Girder	0.011%	0.013%
Loc. 4: Undamaged Exterior Girder	0.006%	0.015%

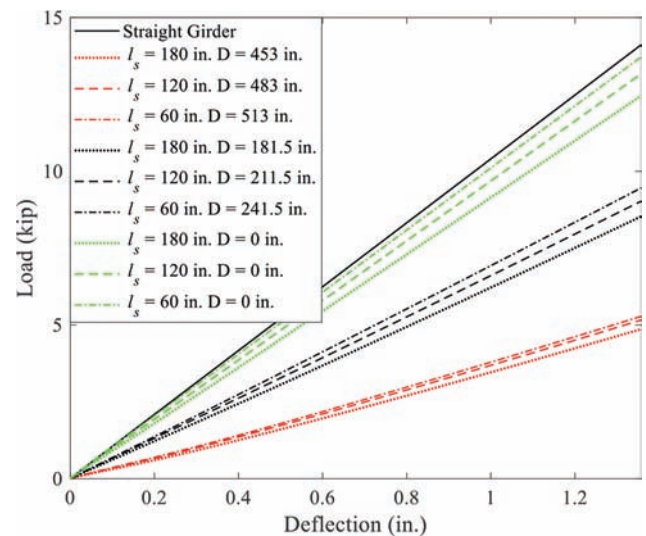
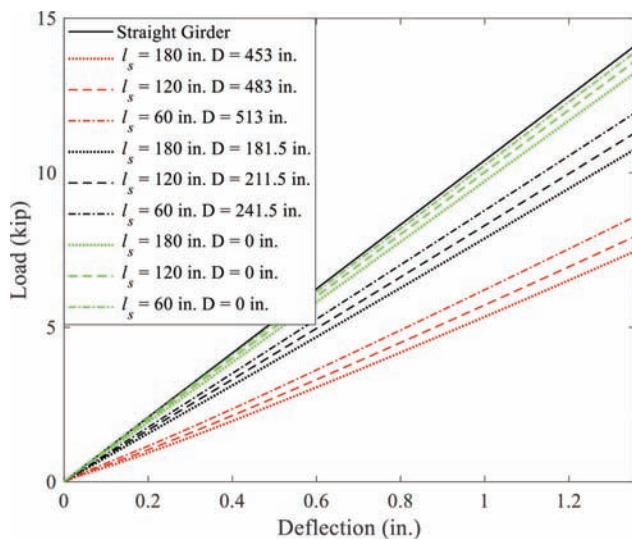
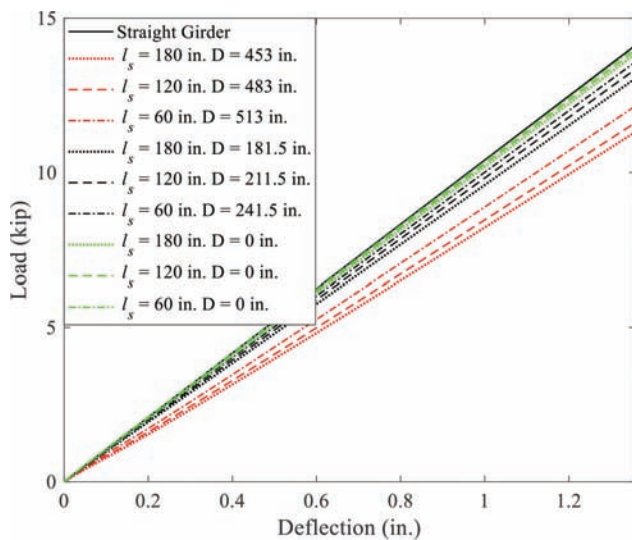
Generally, damage reduces the stiffness of the girder (Table 5.2, Figures 5.1, 5.2, and 5.3). The greater the

Figure 5.1 Load-deflection behavior for  $\alpha=30^\circ$ .

Figure 5.2 Load-deflection behavior for  $\alpha=20^\circ$ .

Figure 5.3 Load-deflection behavior for  $\alpha=10^\circ$ .

rotation angle ( $\alpha$ ), the greater the reduction in the stiffness. As the damage moves from the edge of the girder to midspan, the effect of damage on the stiffness increases. Longer damaged lengths ( $l_s$ ) also decrease the stiffness. The stiffness can drop up to 34.6% that of a straight beam when damage features a large rotation angle, long damage length, and midspan location.

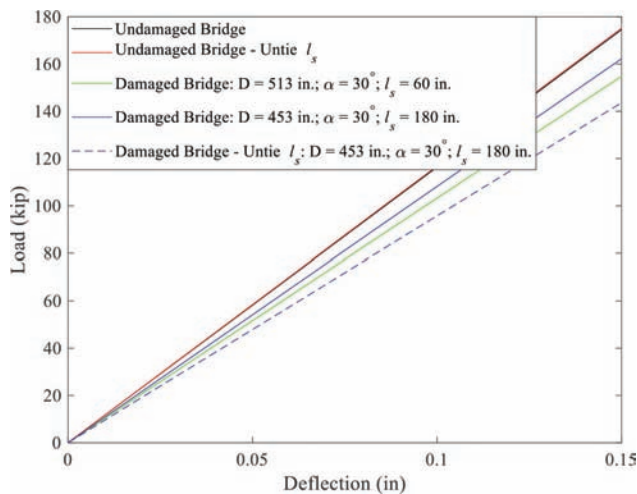
Figure 5.4 Load-deflection behavior of whole bridge.

The damaged girder reduces the stiffness of the entire bridge, compared to a bridge with no damaged girders (Figure 5.4). A shorter damaged length ( $l_s$ ) decreases the stiffness of the bridge more than a longer length. This is in contrast to the findings of the single girder study. It can be attributed to continuity and load redistribution in the entire bridge model, where a longer damaged length is able to redistribute to adjacent girders more effectively than a more localized shorter length. Although damage can cause a significant drop in stiffness, in the single girder study (e.g., for  $\alpha=30^\circ$ ,  $l_s=180$  in.,  $D=S/2-l_s/2$ , the damaged girder only had 34.6% of the stiffness of straight beam). This effect is mitigated in the entire bridge through redistribution to the concrete deck, concrete railing, and adjacent girders (for the same case, the stiffness of the bridge is 92.9% that of an undamaged bridge). The effect of removing the shear connection (or untying the connection between the girder and deck) was also investigated. This had a negligible effect on the undamaged bridge model, but resulted in a drop in stiffness from 92.9% for the undamaged bridge to 82.2% for  $\alpha=30^\circ$ ,  $l_s=180$  in.,  $D=S/2-l_s/2$ .
